RESULTS OF ENVIRONMENTAL FINDINGS FOR THE WHITE HOUSE ACCESS ROAD

Comstock Mining Inc. Soils Assessment Areas Affected by the Carson River Mercury Site Gold Hill, NV

June 11, 2012

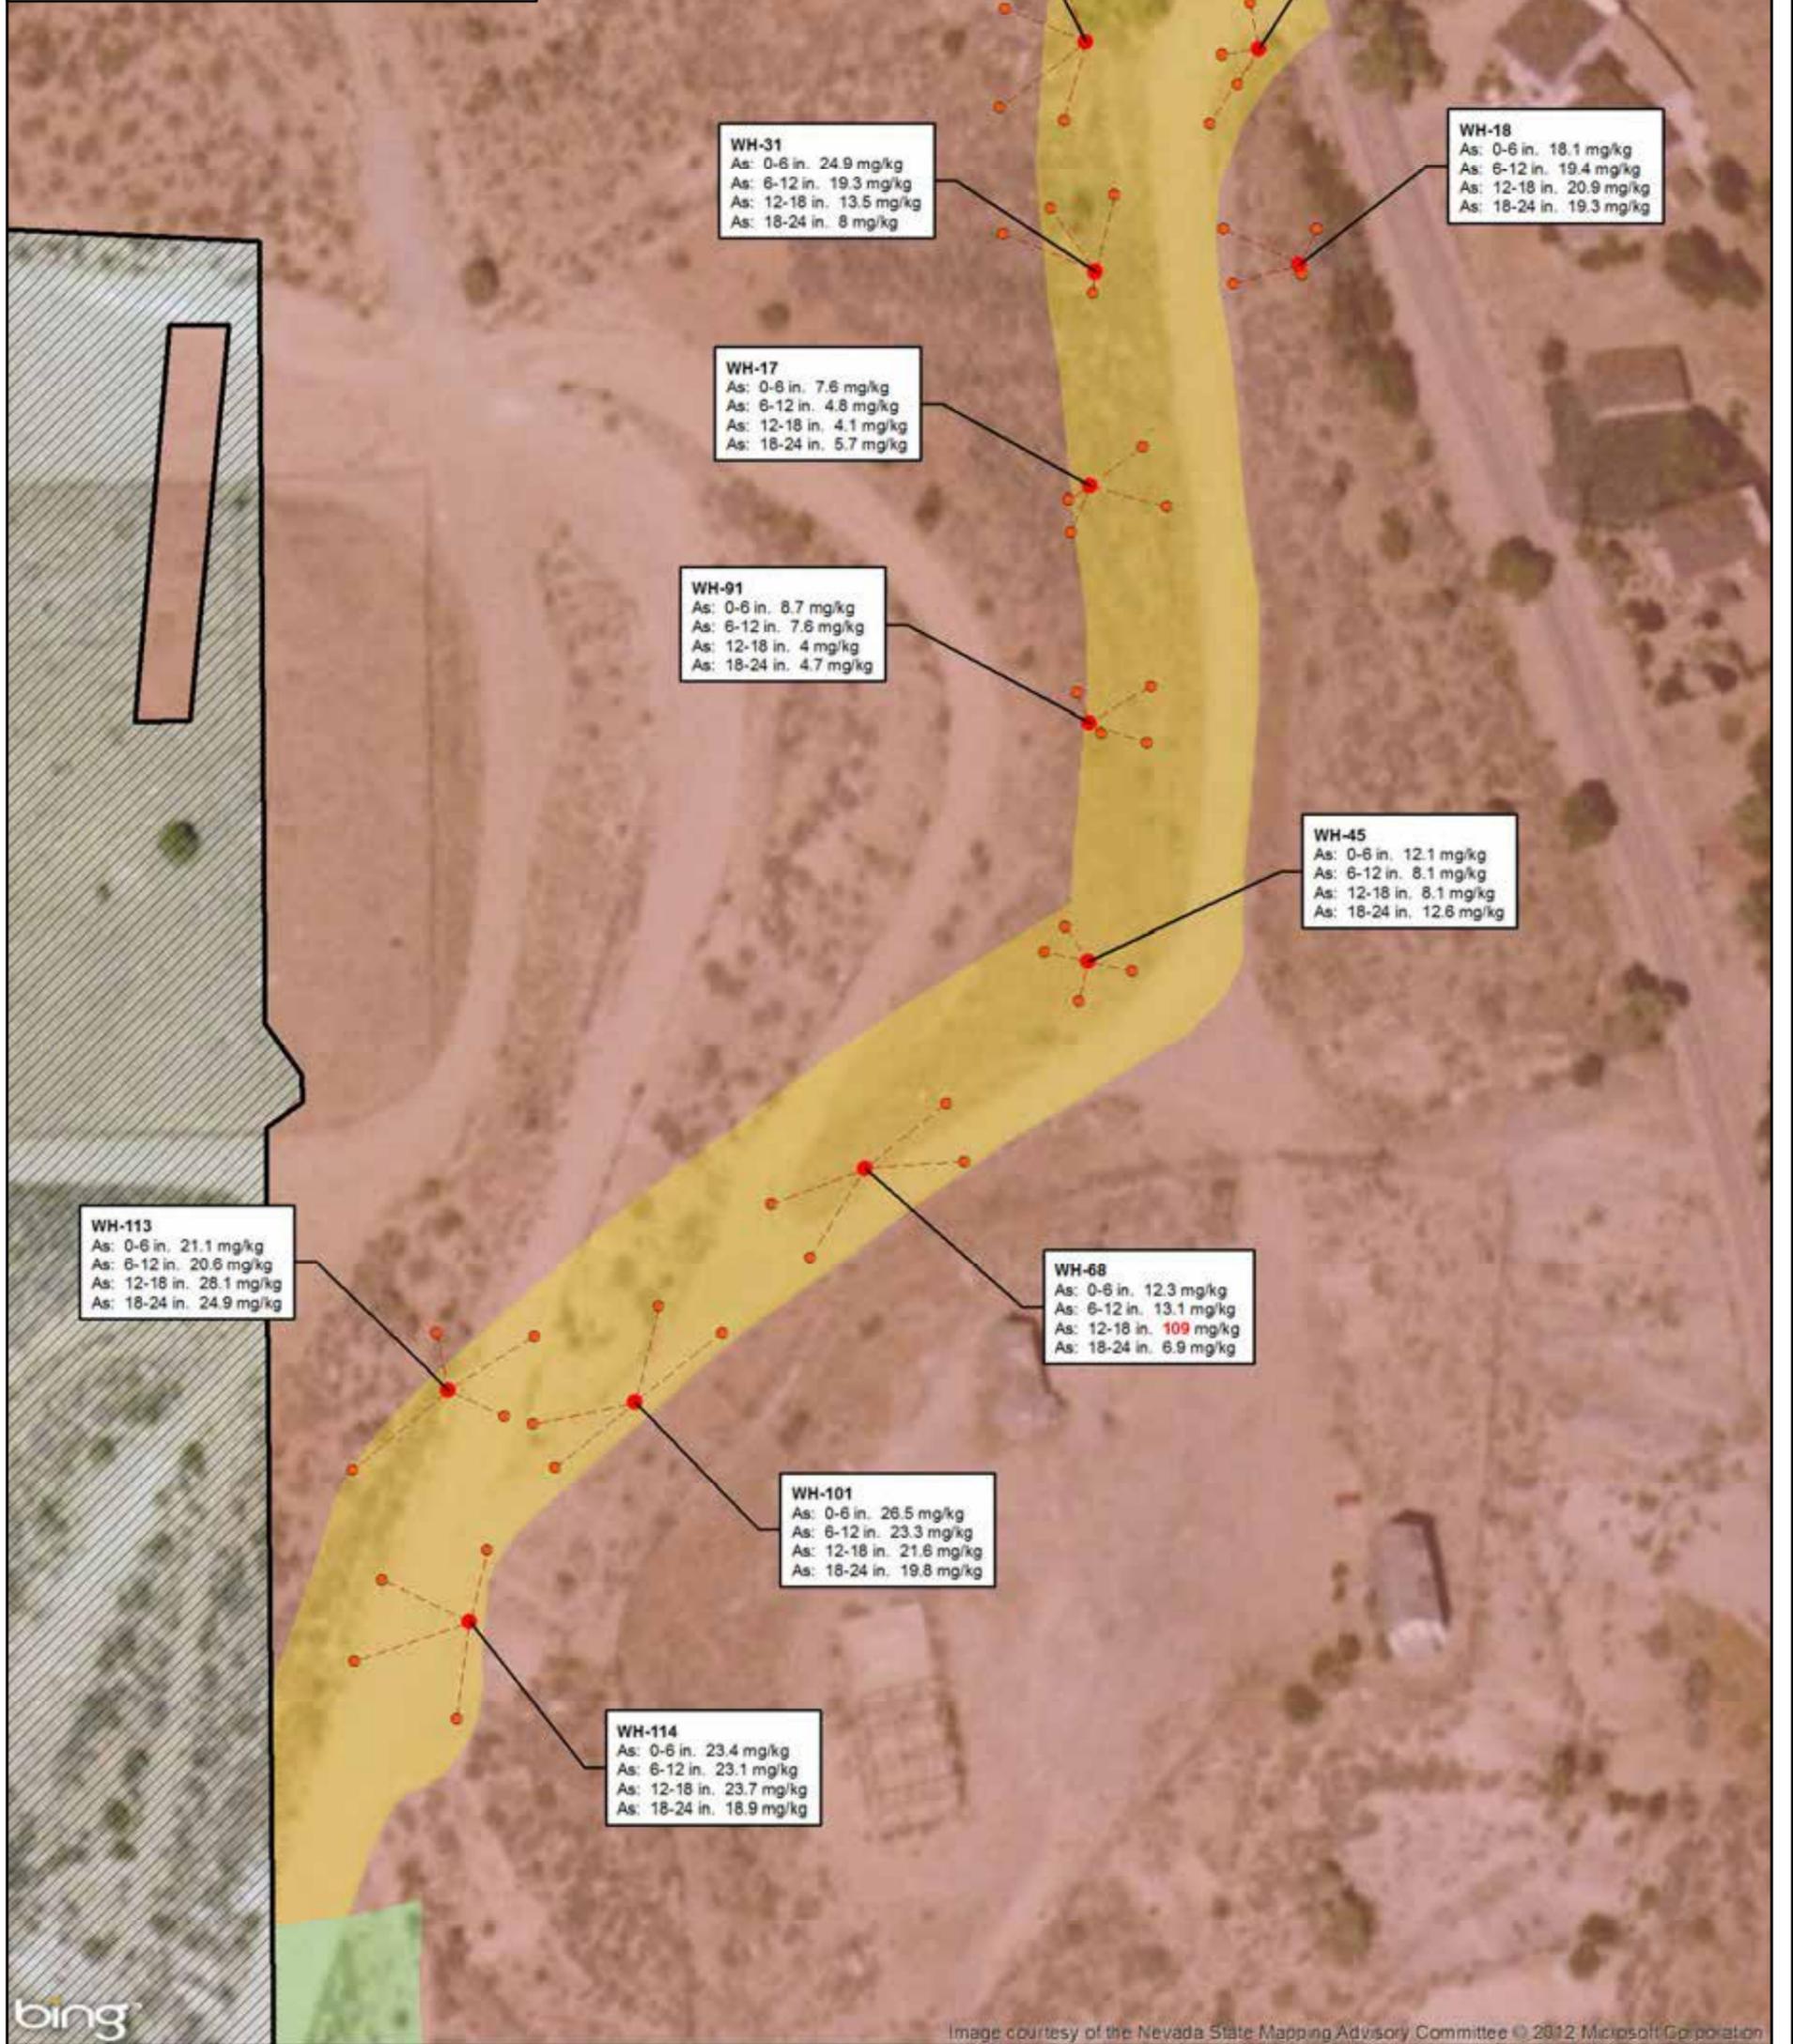
DRAWING TITLE:
White House Access Road Sampling
Soil Concentrations - Arsenic

Arsenic data is presented on Table 1 and Figure 2. There were a number of exceedances of NDEP's Residential Screening/Action Level of 32 mg/Kg. The range of concentrations is from 4 to 109 mg/Kg. The mean concentration is 18.7 mg/Kg. The site mean concentration is below the NDEP's Residential Screening/Action Level.

Comstock evaluated these data as the arsenic data was elevated versus the NDEP's Residential Screening/Action Level, however, there were no detections of other COCs above the NDEP's Residential Screening/Action Levels. The absence of concentrations above the pertinent NDEP Screening/Action Levels for the other COCs is a strong line of evidence that this portion of the

Site is not impacted by historic mine or mill activities. The site history and conceptual site model (CSM) discussed in the NDEP's LTSRP indicates that the COCs should occur together. Furthermore, the LTSRP notes that both lead and arsenic should have been concentrated in the wastes along with the mercury. It is Comstock's belief that the presence of arsenic above the NDEP's Screening/Action Level in the absence of elevated levels of mercury and lead indicate that the arsenic values are representative of background conditions.

The evidence suggests that the arsenic concentrations within the White House Access Road are naturally occurring in association with primary mineralization in the bedrock or at concentrations which are protective of human health and the environment. Consequently, no mitigation measures are needed, other than compliance with existing permits, to allow Comstock to proceed with exploration and mining-related activities at the White House Access Road. NDEP derived through statistical analysis of the data throughout the site what NDEP has termed site-specific background values and provided a range of 0 - 90 mg/Kg for arsenic. There is one location in the White House Access Road which exceeds 90 mg/Kg and its lead concentration is elevated versus the NDEP's range of background values. Comstock believes that the material at the one noted depth within the one noted location is due to naturally occurring mineralization, but at NDEP's request, this location is designated as CERCLA-regulated material (classified as Category 4 materials per NDEP's May 4, 2012 comments).

As noted above, Comstock does not believe that any mitigative measures are necessary as the concentrations of COCs present throughout the White House Access Road are within acceptable health-based levels. There was only one location within the White House Access Road that failed NDEP's criteria for defining CERCLA applicability, location WH-68 at the 12-18" bgs depth. This location is elevated for arsenic and lead. NDEP's ceiling for arsenic is 131 mg/Kg. Mercury concentrations are extremely low at 0.141 mg/Kg versus the NDEP's background range of 0 - 1.5 mg/Kg; the NDEP's Screening/Action Level of 80 mg/Kg (residential); and the NDEP's Screening/Action Level of 300 mg/Kg (commercial/industrial). Lead is also low at 129 mg/Kg versus the NDEP's Screening/Action Level of 400 mg/Kg (residential); and the NDEP's Screening/Action Level of 800 mg/Kg (commercial/industrial). Given the location, the isolation of the arsenic exceedances, and the fact that mercury concentrations are consistent with background, Comstock believes that the arsenic present at WH-68 at 12-18" bgs is naturally occurring nevertheless, at NDEP's direction the area will be managed as CRMS-related CERCLA waste. The area where NDEP believes that CERCLA applies is shown on Figure 5. This area is within an existing road right-of-way, and at depth. The existing usage as a road functions as a cap and is not expected to affect the 12-18" depth. In addition, Comstock plans to improve the existing road by adding additional clean fill materials on top of the existing road materials. In addition, the road will be maintained with dust control measures and/or tacifier that will help to stabilize the road materials. Comstock does not propose any additional mitigative measures at this time. If this area has a change in usage such that the 12-18" bgs depth will be disturbed Comstock will propose additional mitigative measures including potentially proposing additional sampling to define the nature and extent of the COCs.

With the exception of the single point at 12-18" bgs at location WH-68, the White House Access Road is within NDEP Categories 1-3 and requires no further action and is proposed for removal from the CRMS.

Regarding location WH-68 at 18-24" bgs Comstock proposes that no further action is required at this time because it will remain within a road right-of-way at depth and will remain undisturbed and the road will function as a cap. Comstock will maintain this road as part of its business operations and will place a crushed rock cap and/or dust suppressant on top of the soils. In this manner the road will function as a cap for the materials located at 12-18" bgs at location WH-68. Should Comstock change the use of that location in the future, additional mitigation measures will be elevated and submitted to BCA.

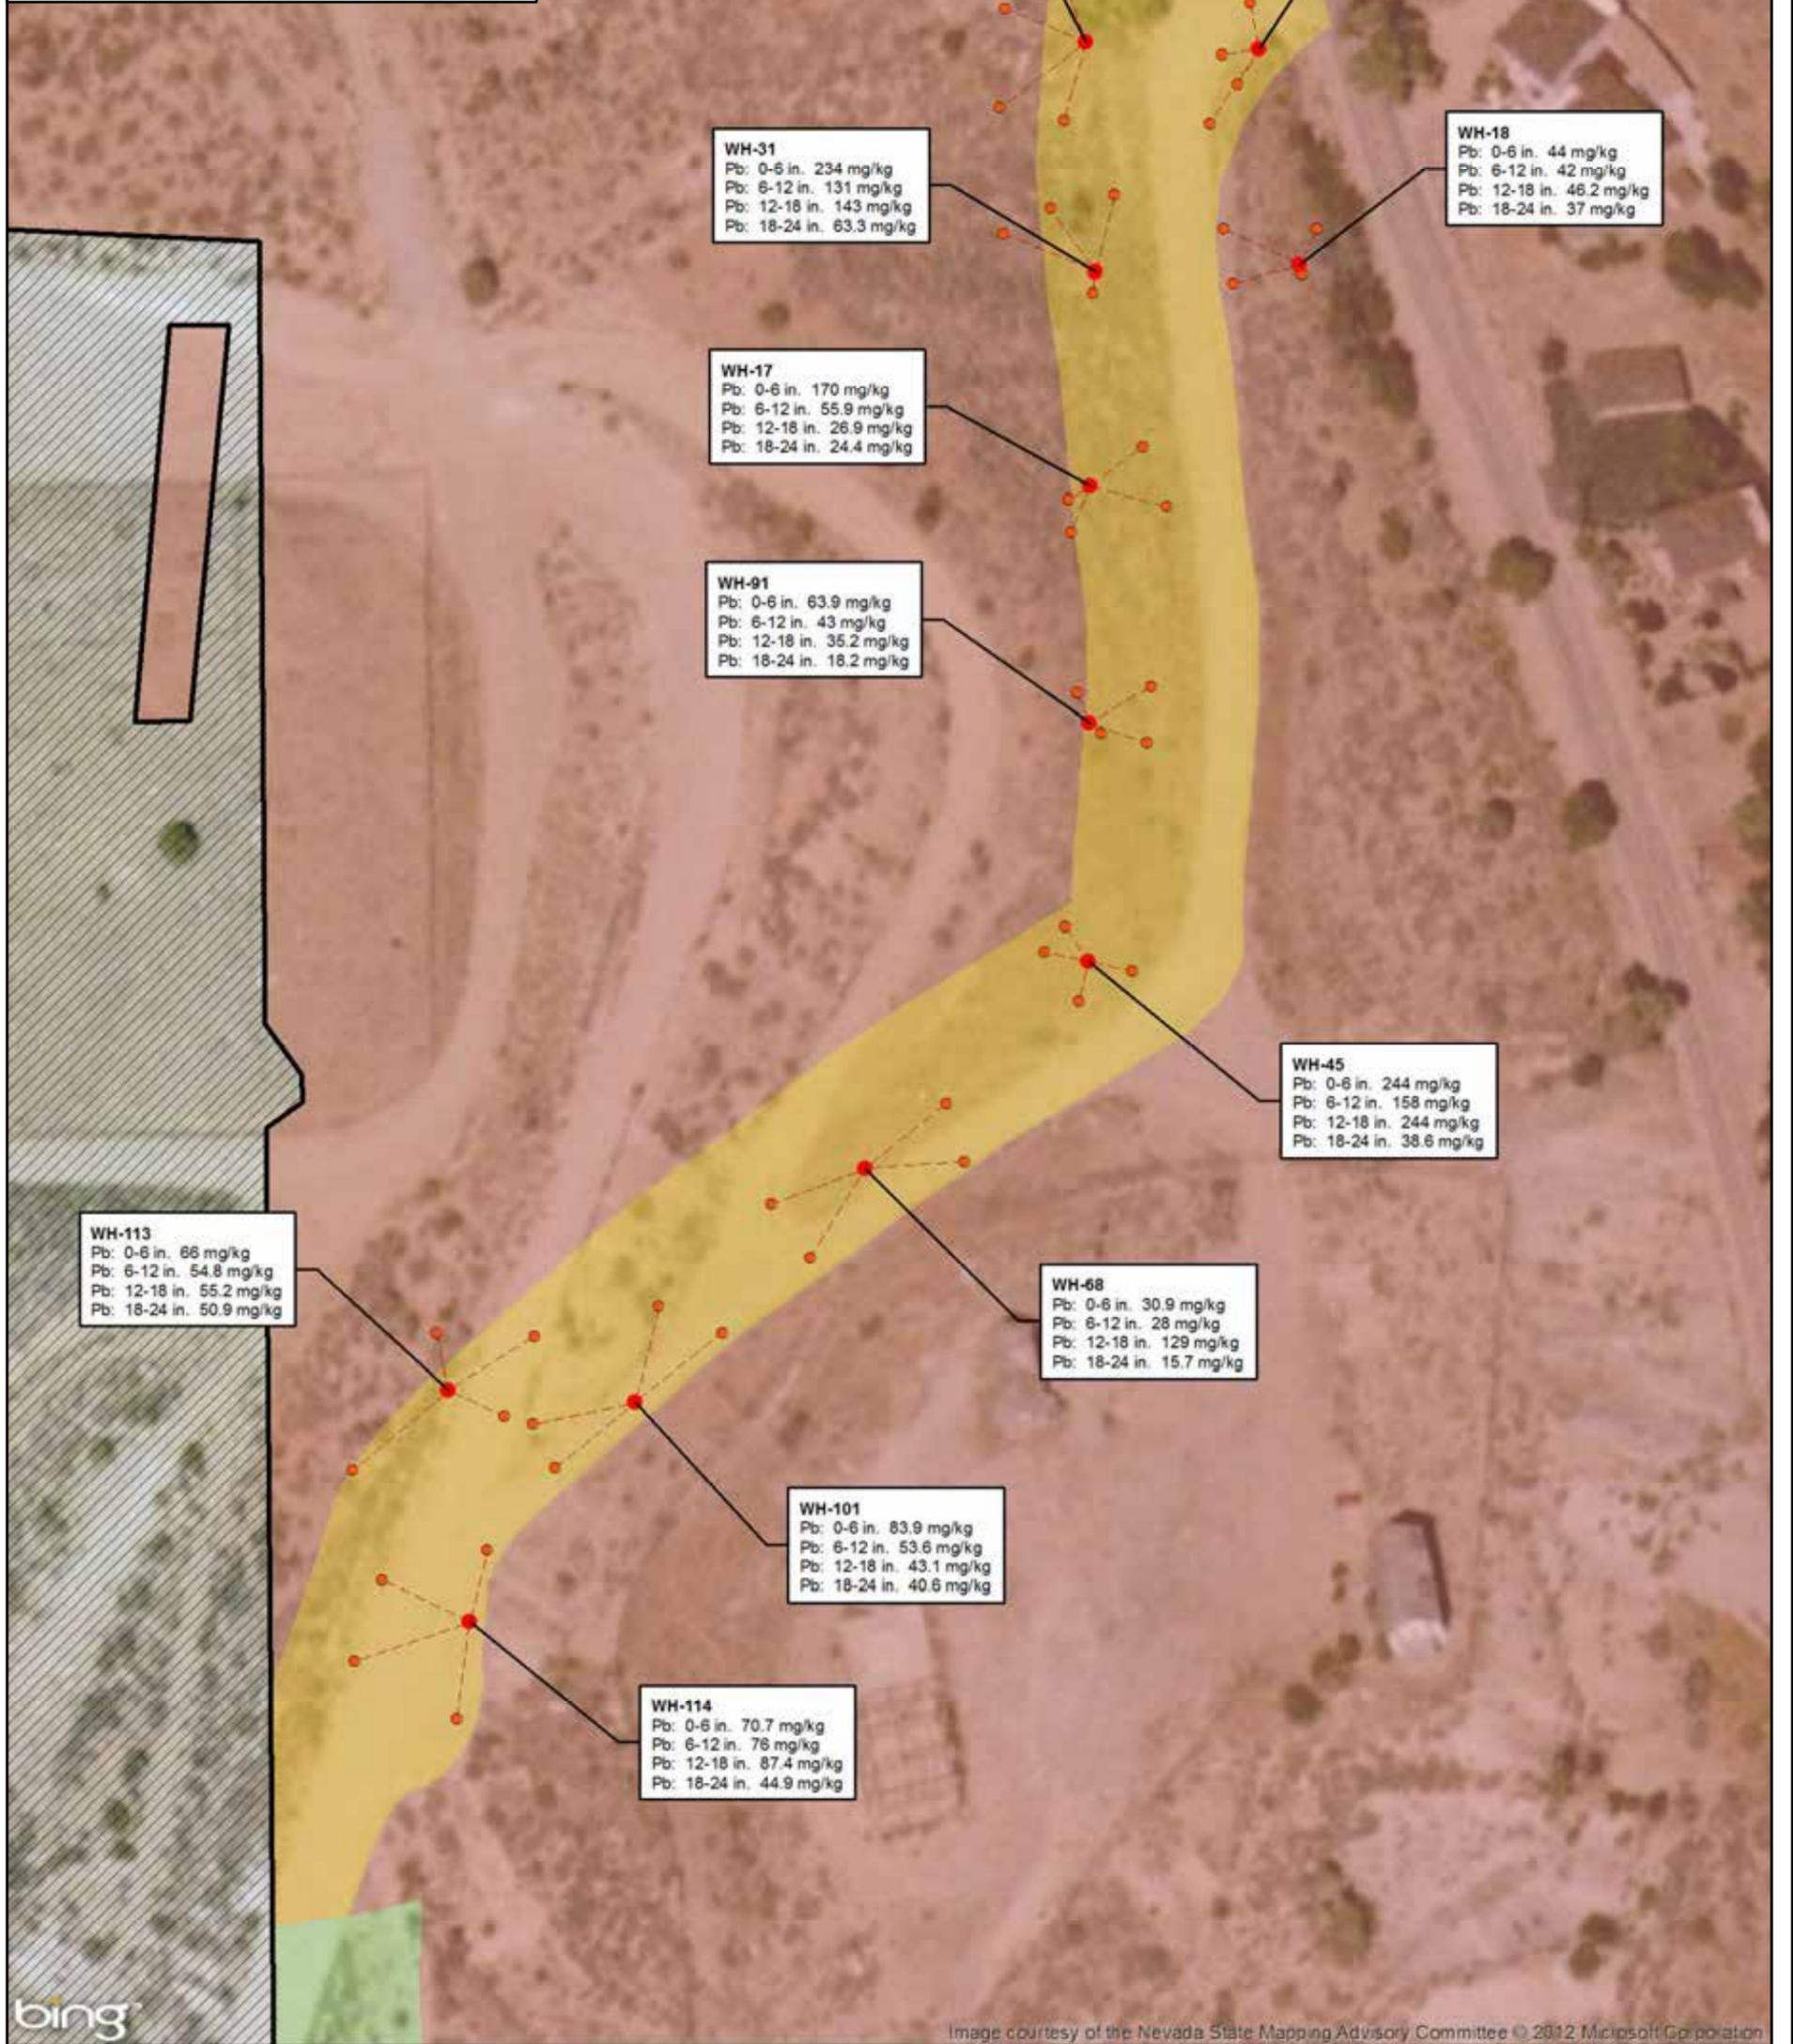
Lead data is presented on Table 1 and Figure 3. There were no exceedances of the NDEP's Residential Screening/Action Level. The range of concentrations is from 15.7 to 244 mg/Kg. The mean concentration is 86.44 mg/Kg. These data show that the lead concentrations within the White House Access Road are well below the NDEP's Residential Screening/Action Level of 400 mg/Kg. The site will be used as a road and the NDEP's Commercial Screening/Action Level is 800 mg/Kg as a point of reference.

NDEP derived site-specific background values and provided a range of 0 - 63 mg/Kg for lead. There are several locations at the site which exceed 63 mg/Kg, however, all locations are below NDEP's Screening/Action Levels and/or site-specific background values as derived by the NDEP. These are all classified as Category 3 materials as defined in the NDEP's May 4, 2012 letter and hence are not regulated under CERCLA.

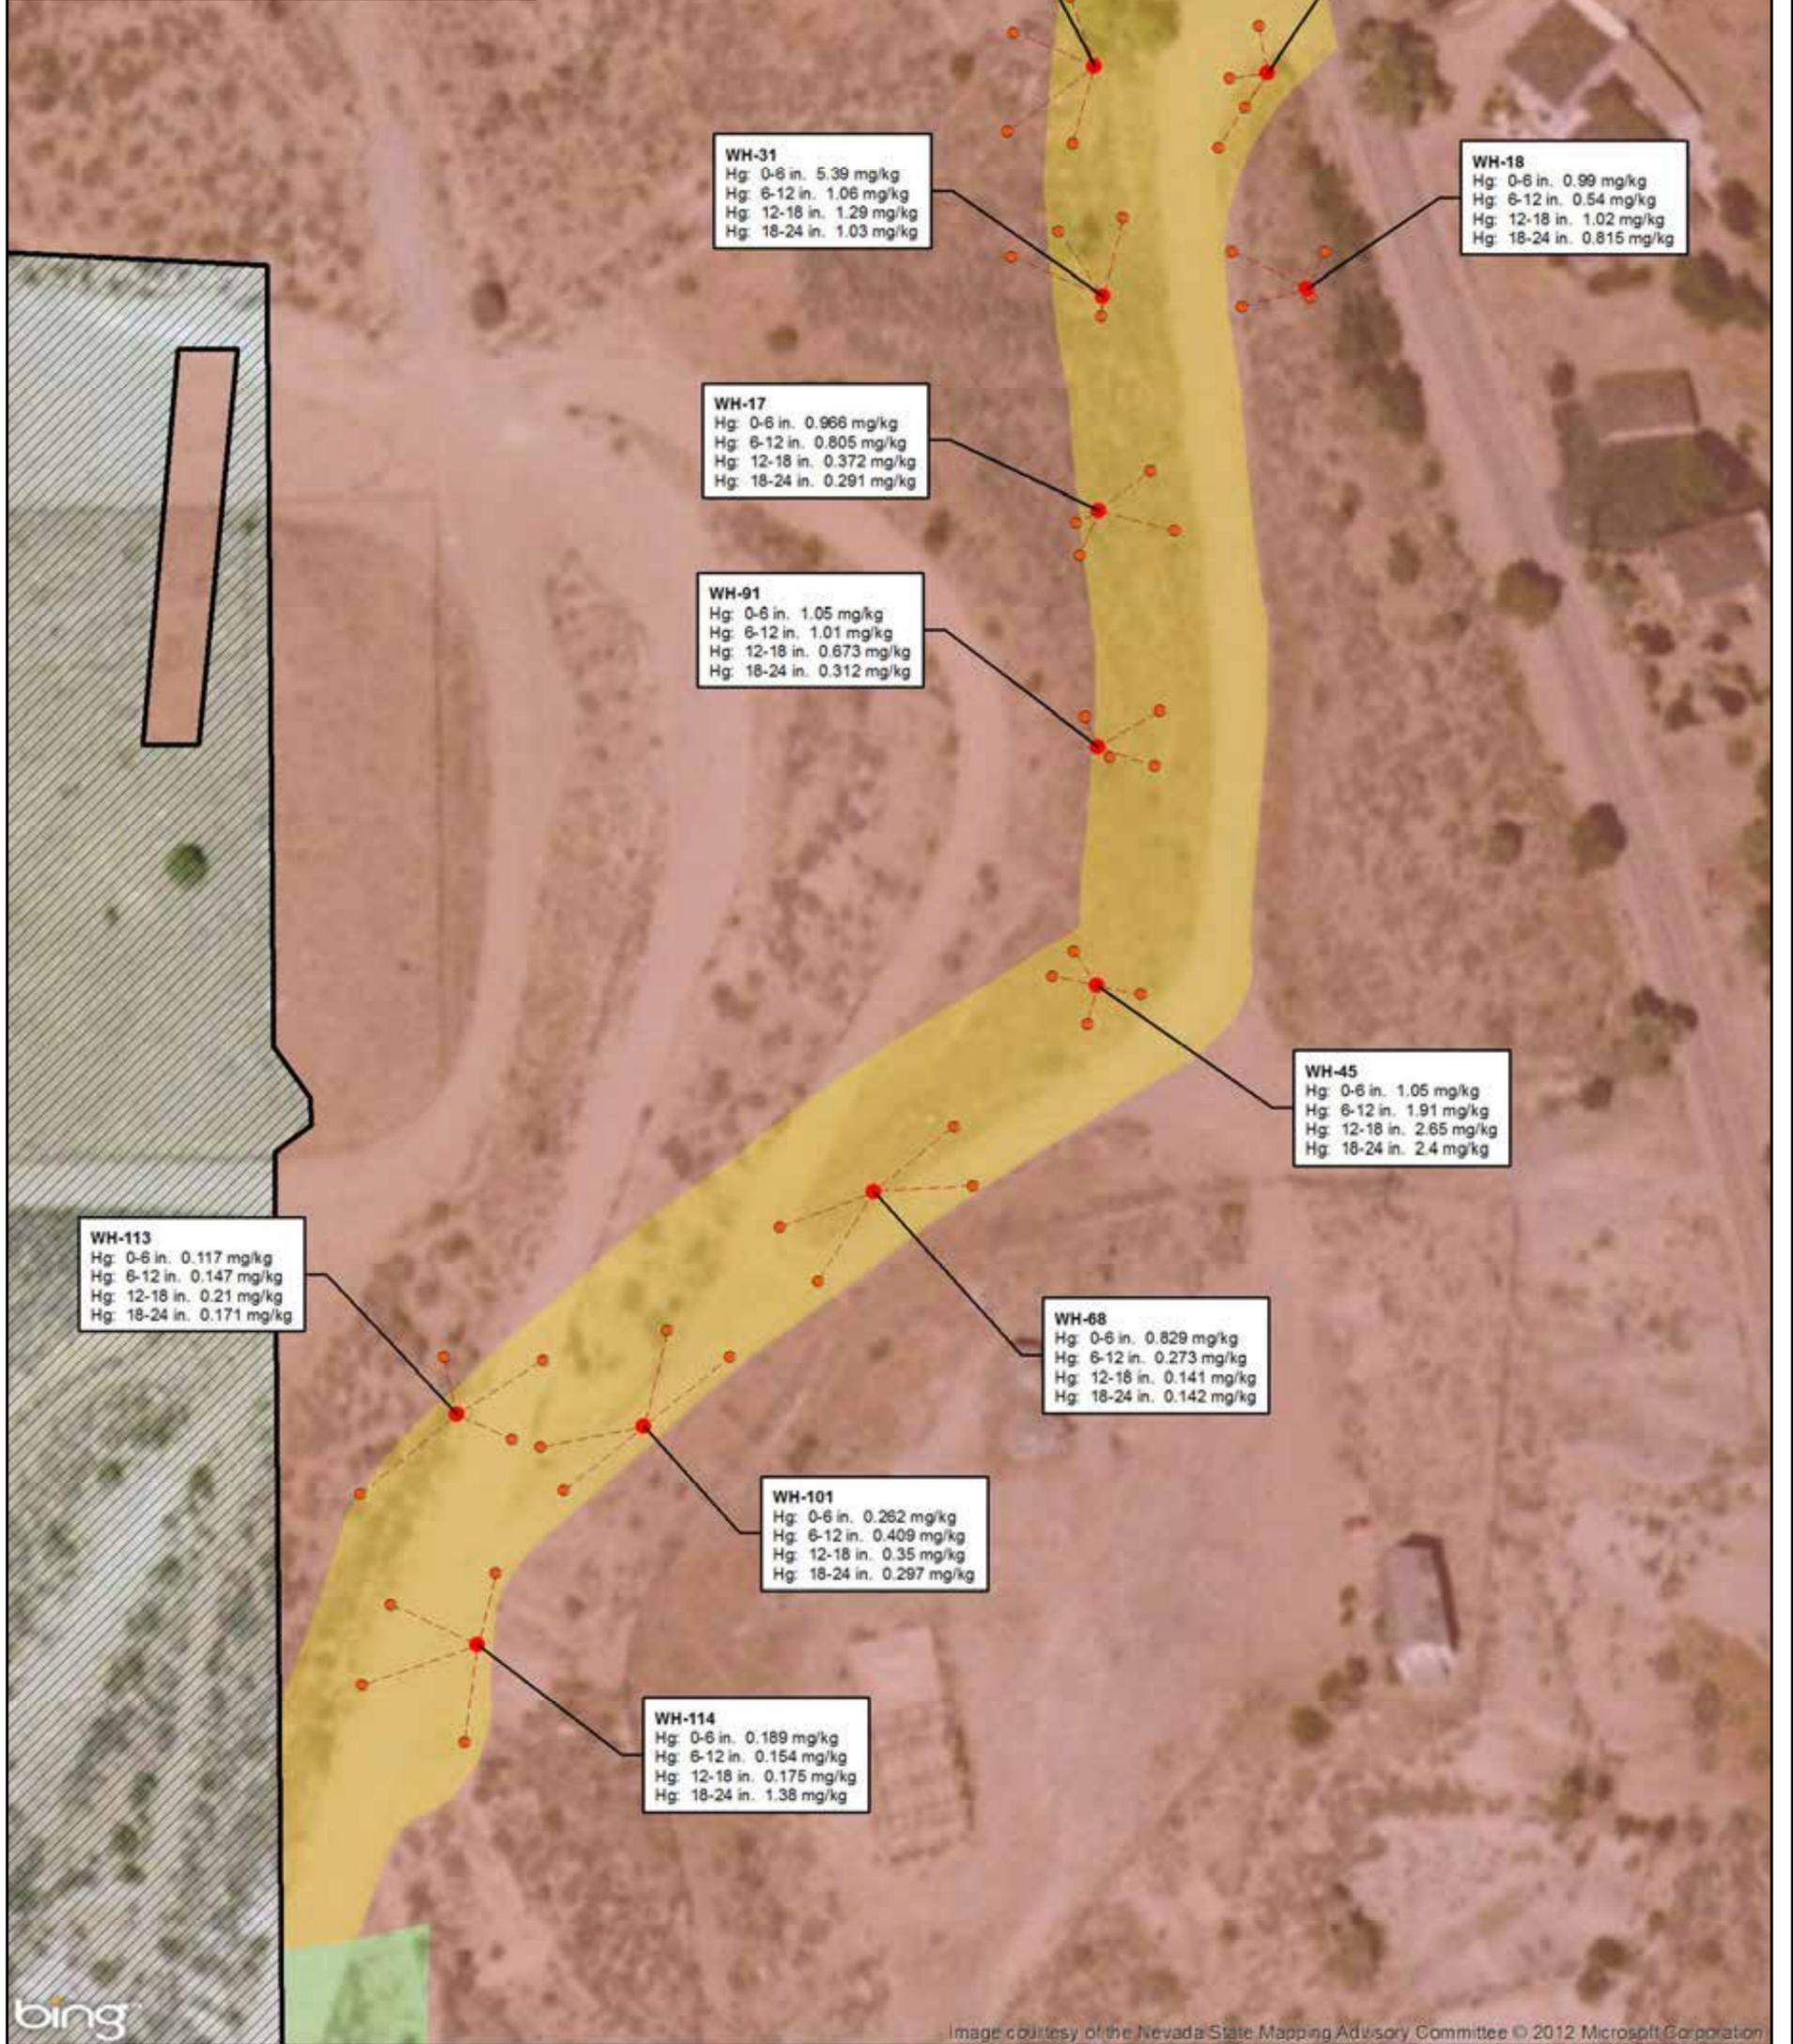
Mercury data is presented on Table 1 and Figure 4. There were no exceedances of the NDEP's Residential Screening/Action Level. The range of concentrations is from 0.0117 to 10.8 mg/Kg. The mean concentration is 1.52 mg/Kg. These data show that the mercury concentrations within the White House Access Road are well below the NDEP's Residential Screening/Action Level of 80 mg/Kg. The site will be used as a road and the NDEP's Commercial Screening/Action Level is 300 mg/Kg as a point of reference.

NDEP derived site-specific background values and provided a range of 0 - 1.5 mg/Kg for mercury. There are several locations at the site which exceed 1.5 mg/Kg, however, all locations are below NDEP's Screening/Action Levels and/or site-specific background values as derived by the NDEP. These are all classified as Category 3 materials as defined in the NDEP's May 4, 2012 letter and hence are not regulated under CERCLA.

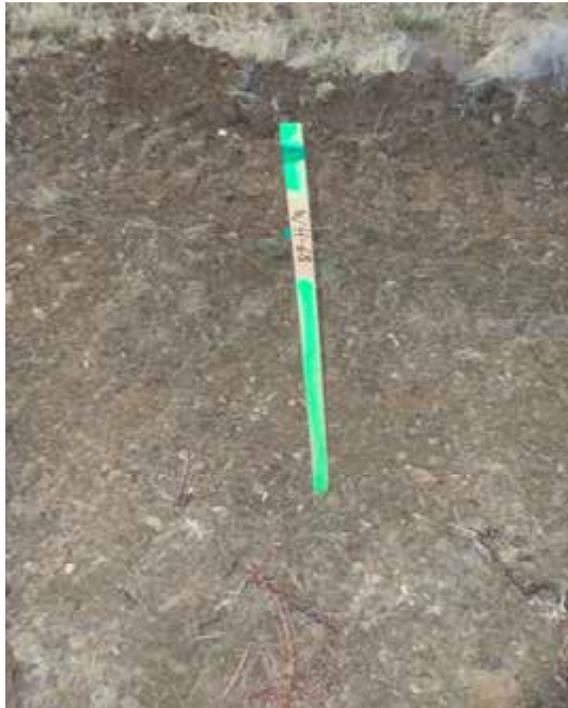
NDEP noted that for special cases the ceiling level for arsenic could be 131 mg/Kg if lead and mercury were below the NDEP-derived background levels. There is one location which fails this criteria. This is location WH-68 at the 12-18" depth. The proposed path forward for this location will be discussed below.
