**Closure Units 1 and 2 Work Completion Report, Revision 1**  
Three Kids Mine  
Henderson, Nevada

Project No. 23-01-200

**Closure Units 1 and 2 Work Completion Report, Revision 1  
Three Kids Mine  
Henderson, Nevada**

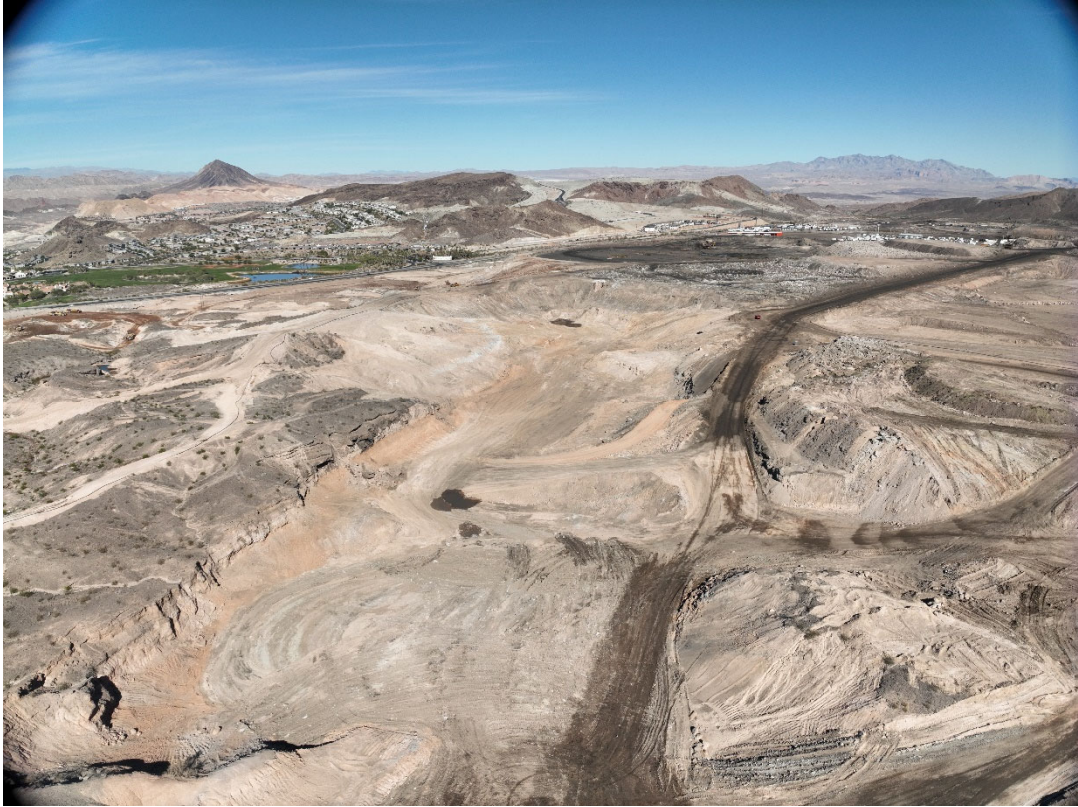
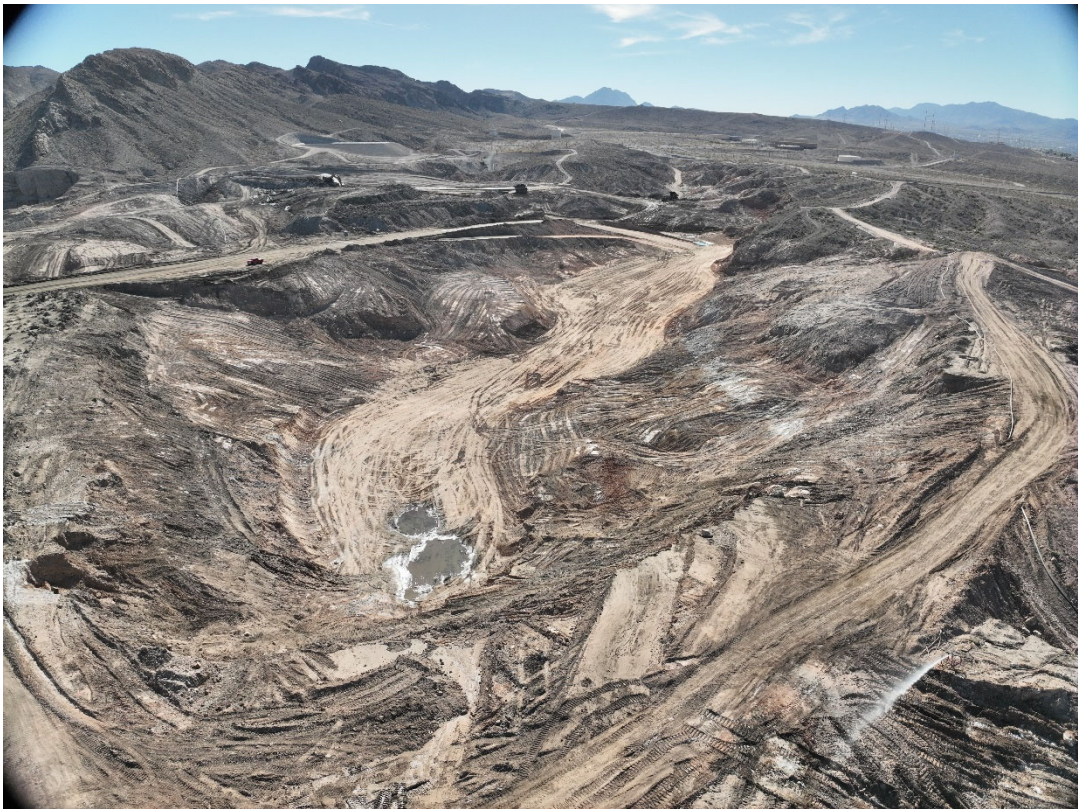
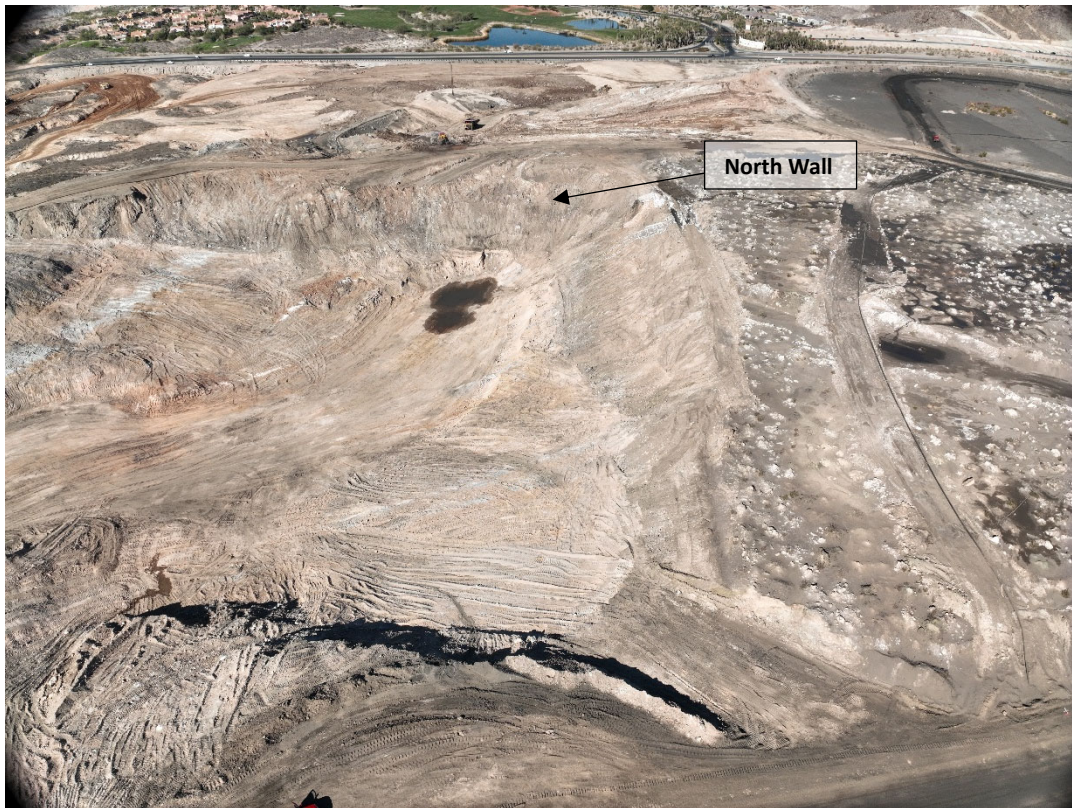
**Tailings Pond 2 North – November 18, 2024**

The north wall of the former Tailings Pond 2 was observed to have a gray color but was interpreted to be waste rock. Supporting evidence for this interpretation is described below. The north wall was an approximately 60-foot slope angled at about 45 degrees. The far northern edge of the wall is approximately 200 feet past the observed surface expression of Tailings Pond 2 during the Remedial Investigation. The top two-thirds of the slope varied in color from light gray to tan to white, while the bottom third was typically tan to white, similar to the floor of the former tailings pond. The grain size of material on the top two-thirds of the Tailings Pond 2 North wall was observed to be trace silt, fine to coarse sand, fine to coarse gravel, cobbles up to 12 inches, and boulders up to two feet. Boulders contained significant amounts of white material, interpreted to be gypsum, which is typical of waste rock material at the Site. This is distinctly different from tailings, which consists of clay, silt, and fine sand. The color of gray material on the top two-thirds of the north wall is lighter than waste rock observed in other locations of the Site, as waste rock color varies from light gray to darker gray to tan. The north wall of Tailings Pond 2 is depicted on page seven of Appendix B.

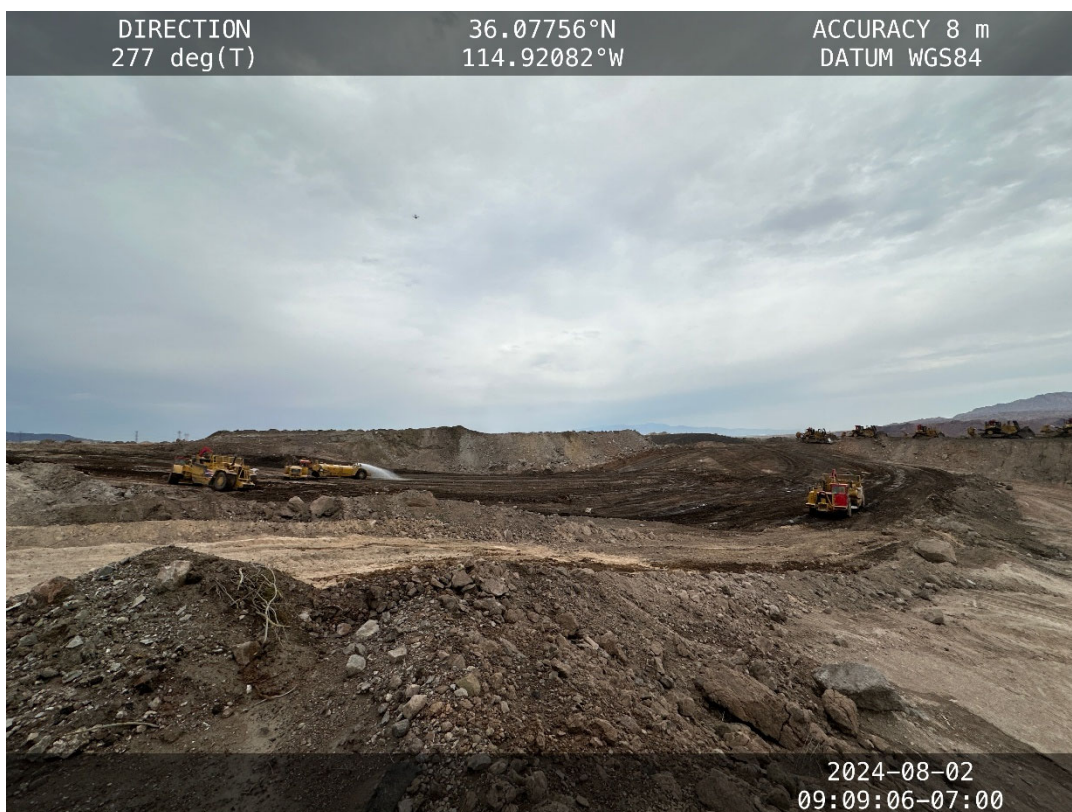
Following CEM clearance of Tailings Pond 3 West on July 22, 2024, waste rock was transported to the area cleared of tailings beginning on July 31, 2024. Waste rock was excavated, transported, placed, and compacted using bulldozers and scrapers, with assistance from water units for dust control and water conditioning. After NDEP approved Remedial Design Modification No. 1 on July 31, 2024 which expanded Closure Units to the southern boundary of the Central Valley Area, movement of waste rock up to the southern boundary of the Central Valley Area was initiated on August 14, 2024 using the same means and methods. Following CEM clearance of Tailings Pond 3 East on August 13, 2024, waste rock was transported to the former Tailings Pond 3 East beginning on August 21, 2024. Following CEM clearance of Tailings Pond 2 South on September 3, 2024, waste rock was transported to the former Tailings Pond 2 beginning on October 1, 2024. Following CEM clearance of Tailings Pond 2 North on November 14, 2024, waste rock was transported to the northern portion of former Tailings Pond 2 beginning on November 21, 2024. Waste rock material was placed and compacted up to 10 feet below final grades throughout Closure Units 1 and 2.

**Waste Rock Reclamation in Tailings Pond 3 West – August 2, 2024**

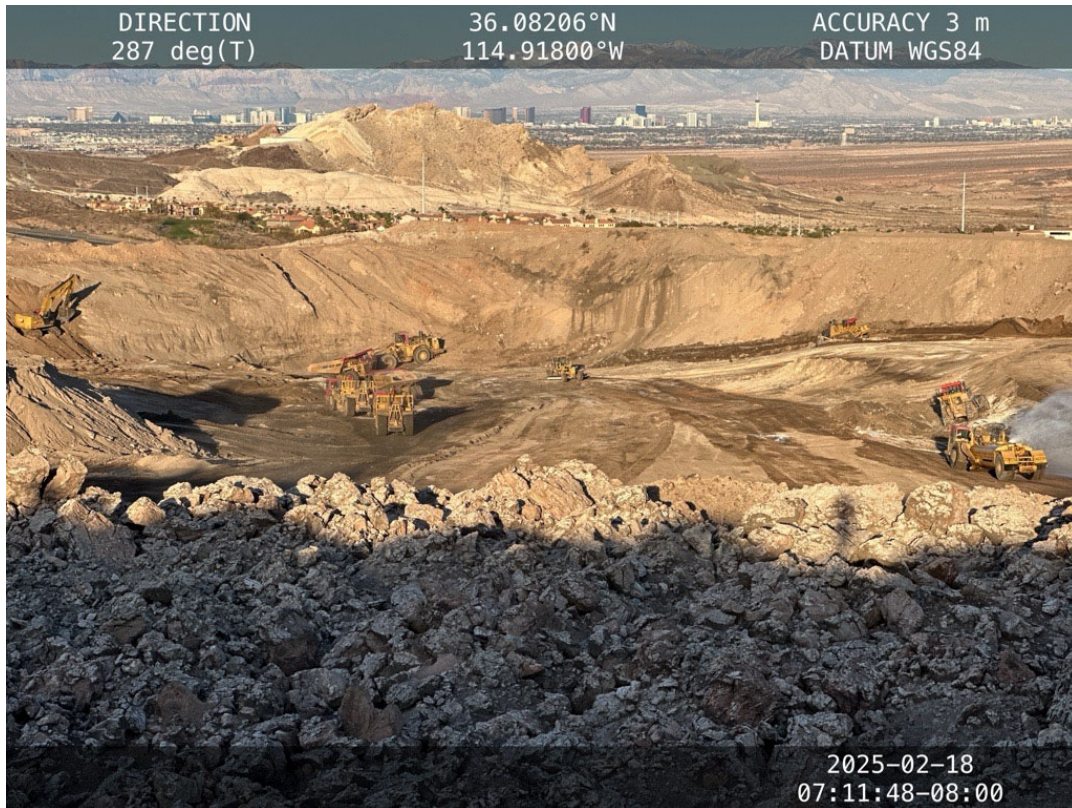
Waste Rock Reclamation in Tailings Pond 2 North – February 18, 2025

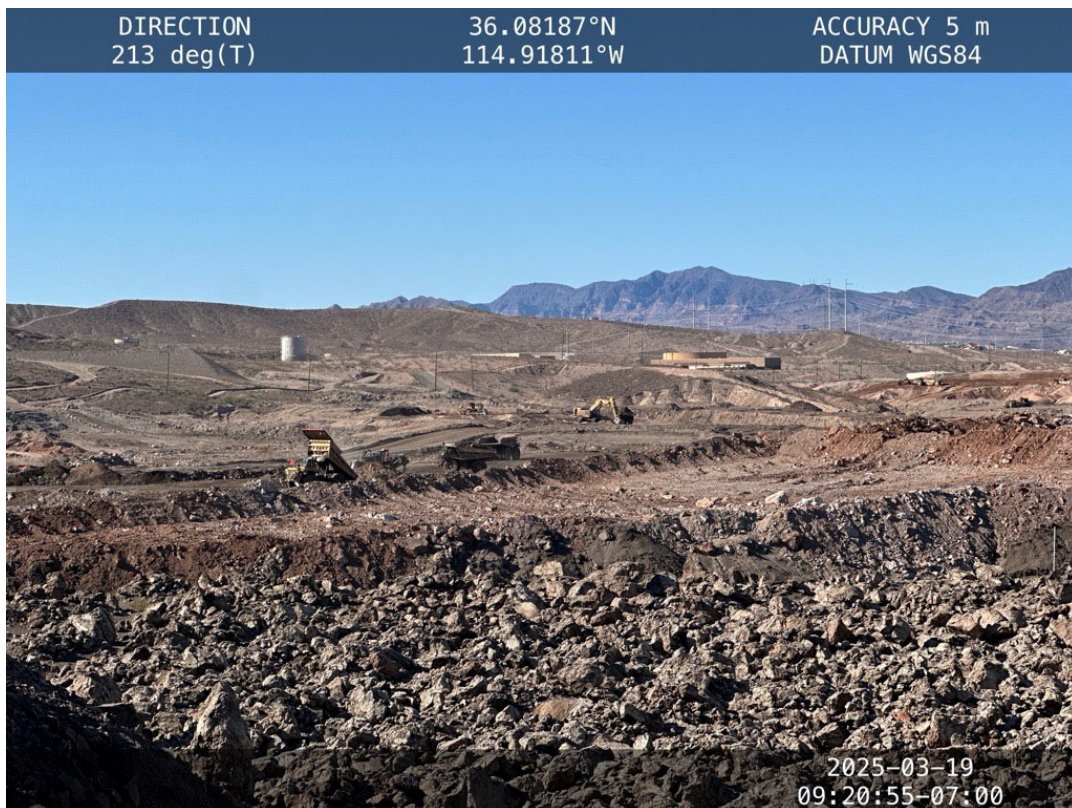
Waste Rock Reclamation in Closure Unit 1 – March 19, 2025

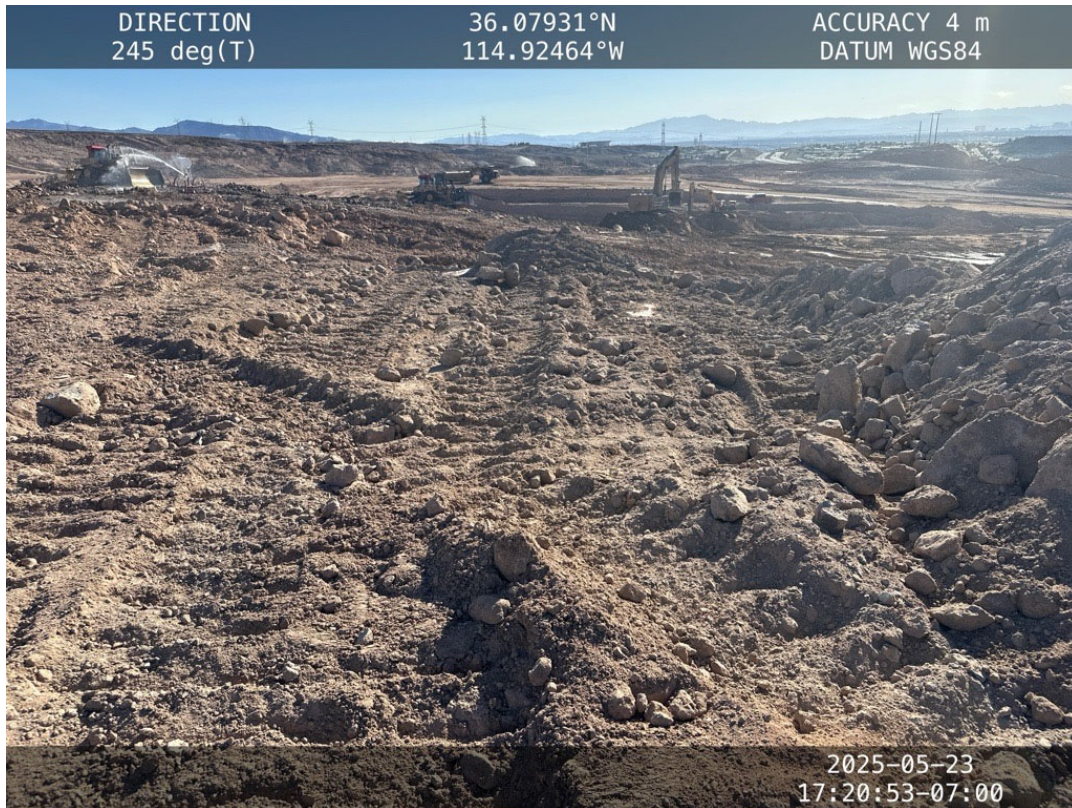
Waste Rock Reclamation in Closure Unit 1 – May 23, 2025

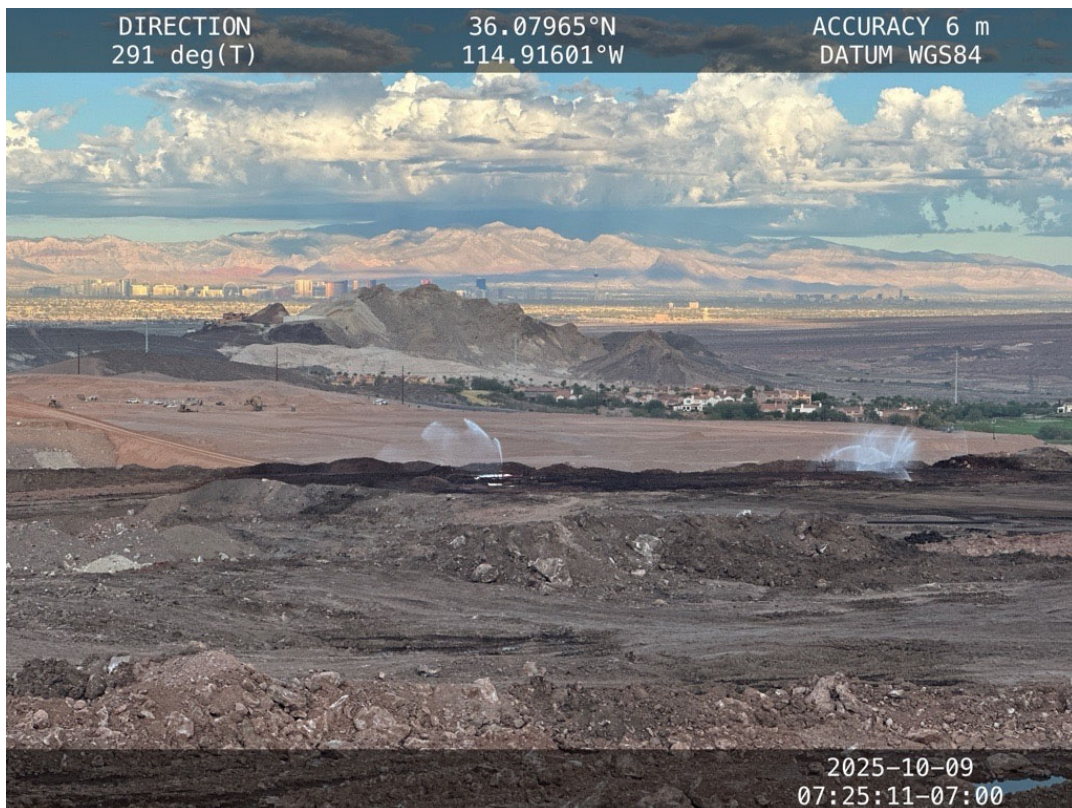
Pre-watering waste rock prior to movement in Closure Unit 1 – October 9, 2025

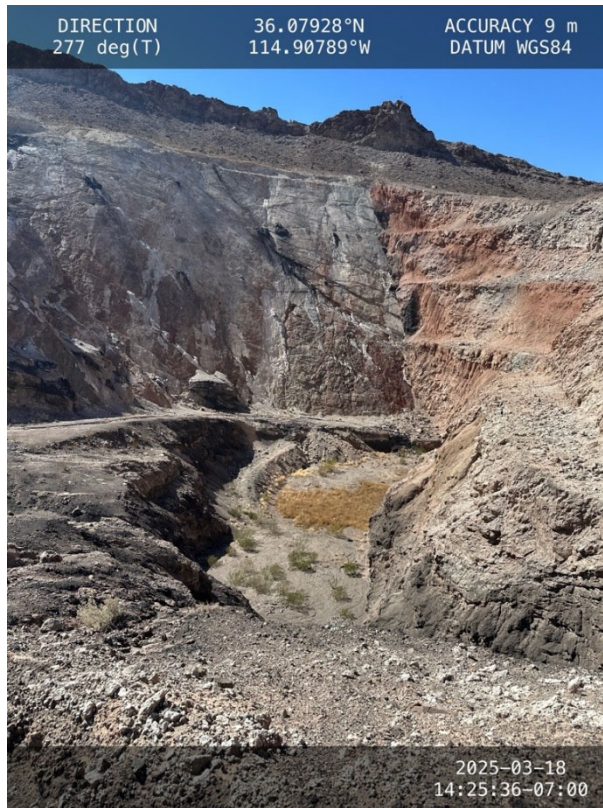
**Hulin Pit prior to backfill with waste rock – March 18, 2025**

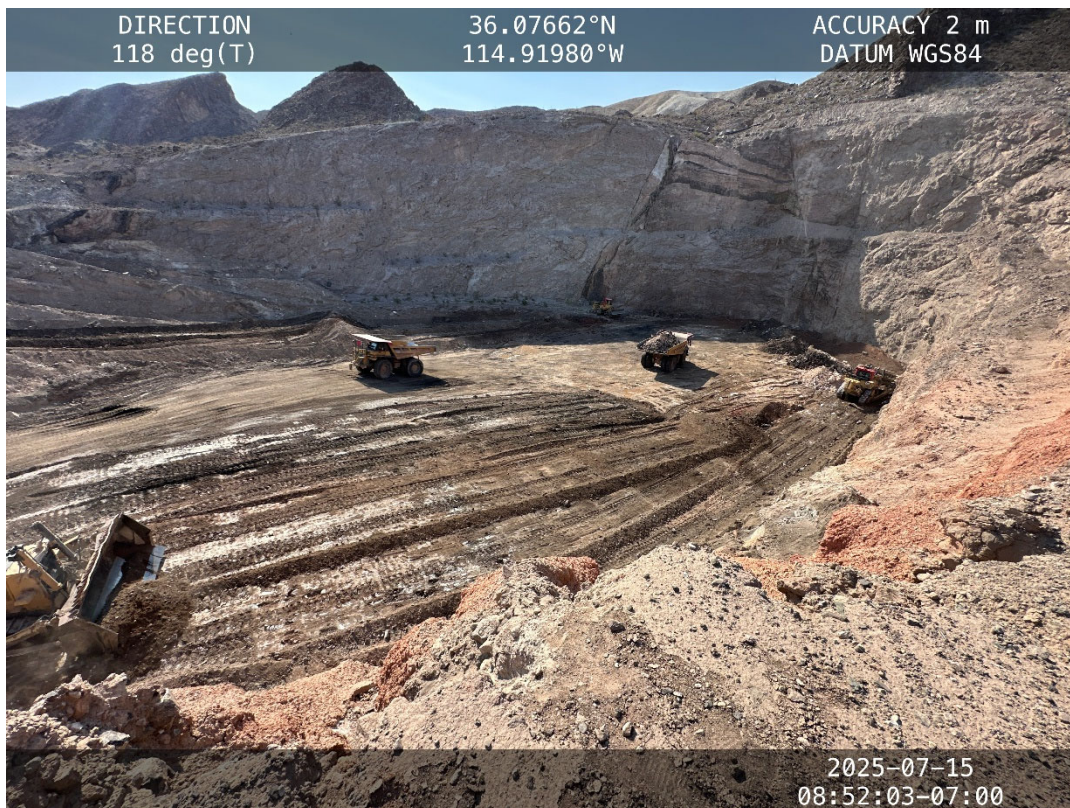
**Waste Rock Reclamation in Closure Unit 2, backfill of the Hulin Pit – July 15, 2025**

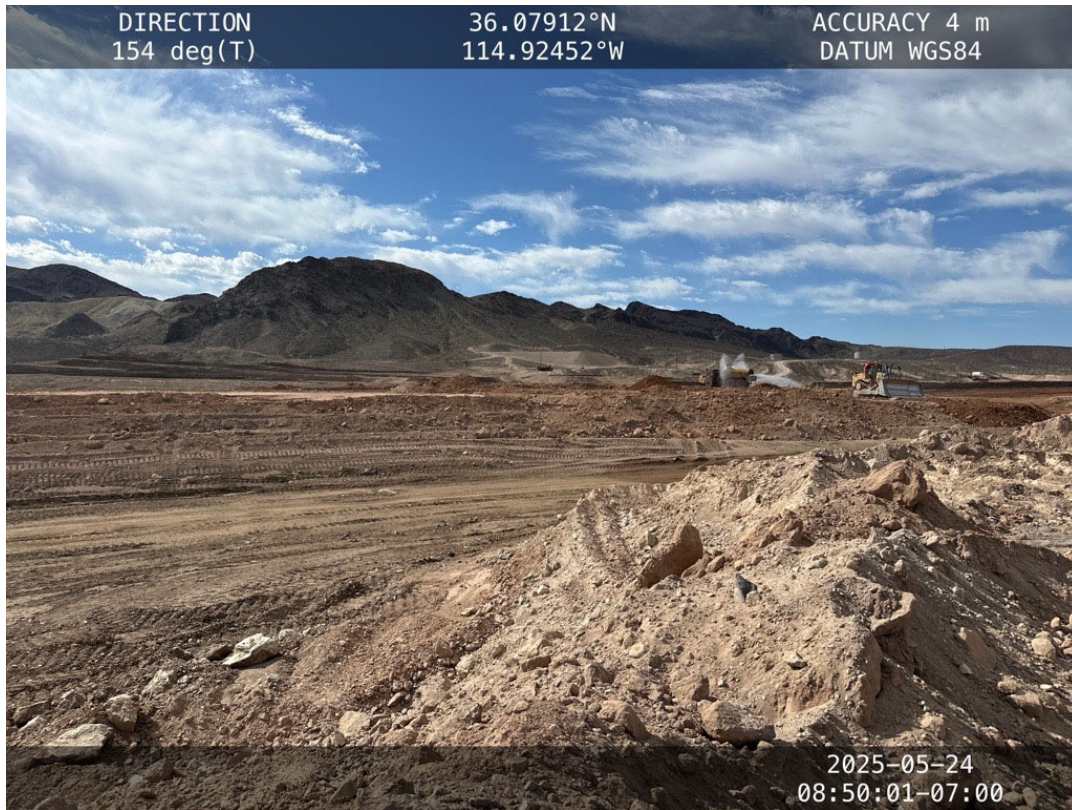
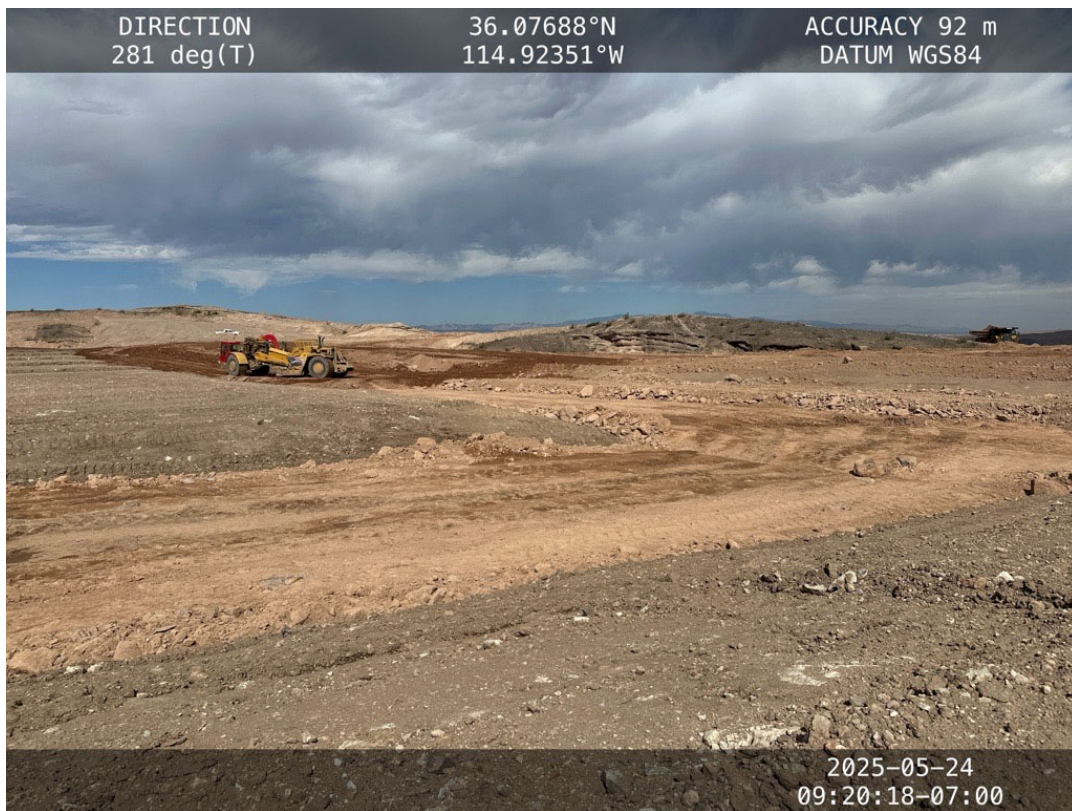
Cover Placement in Closure Unit 1 – May 24, 2025

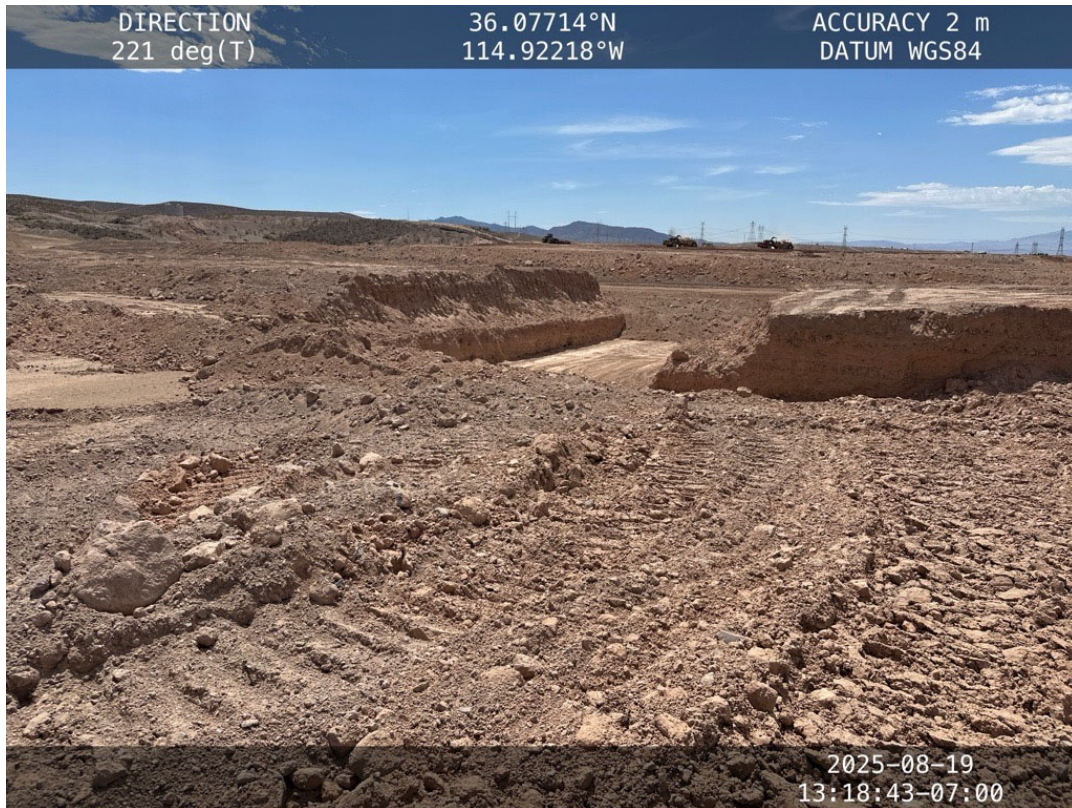
Cover Placement in Closure Unit 1 – August 19, 2025

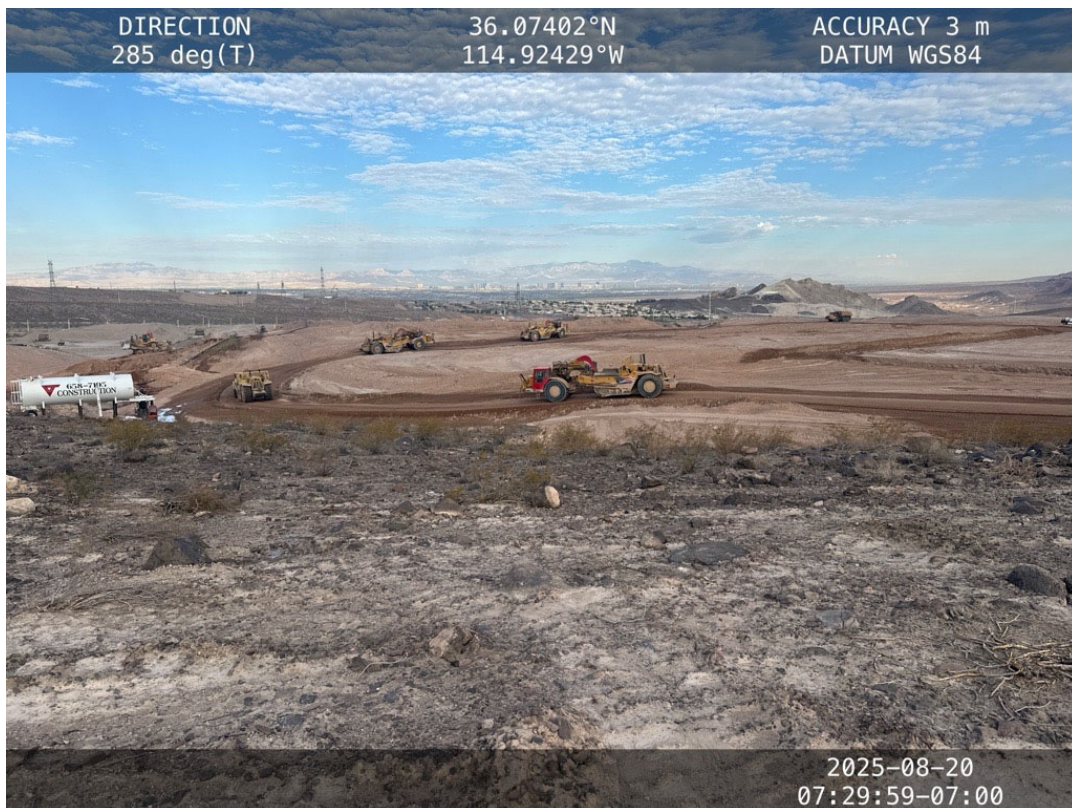
Cover Placement in Closure Unit 1 – August 20, 2025
