Asbestos Survey Report – Revision 2
Former Three Kids Mine Facility
Henderson, Nevada

April 6, 2022

Project No. 14-01-156

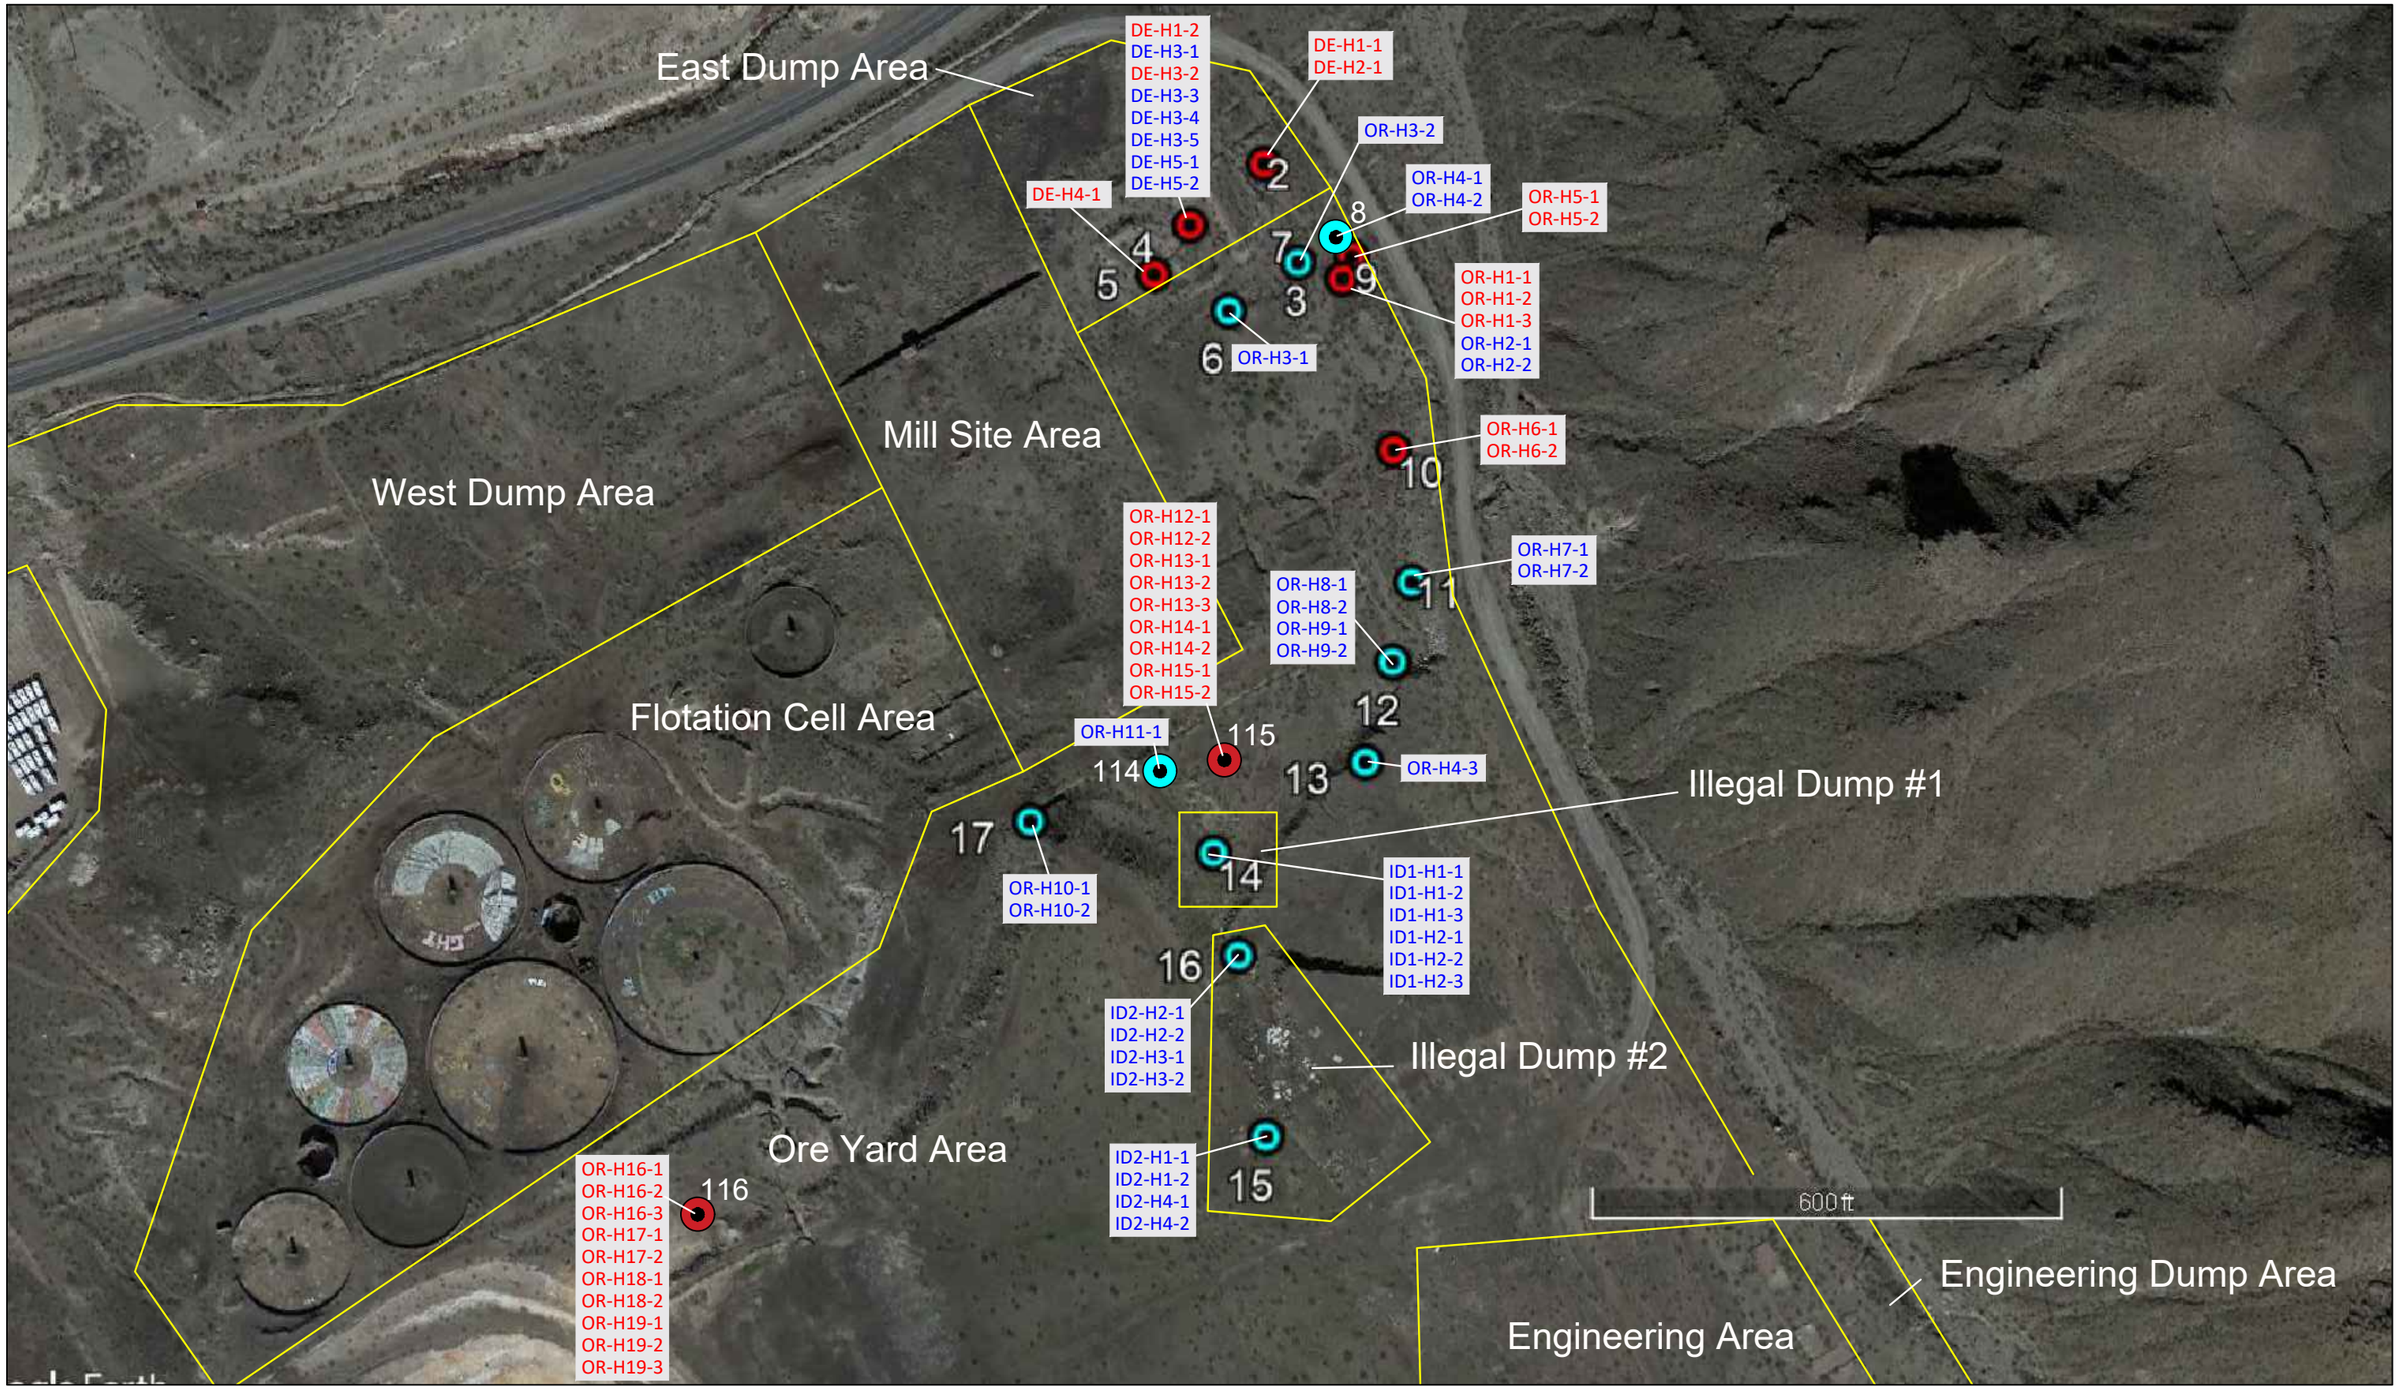
Figure No. 6

1) Friable **Gray Transite Debris** containing 15% chrysotile was observed in sporadic and trace volumes on the ground within the boundaries of the Mill Site Area (Waypoint 42; Sample Identifications MS-H7-1). The material was observed to be in damaged condition. **(RACM, Class IV)**.

Prior to redevelopment activities, Broadbent recommends that the RACM debris identified on the ground within the Mill Site Area is removed by a licensed abatement contractor in accordance with applicable regulations. Subsequent to the completion of the removal activities, post abatement inspections should be performed by a licensed abatement consultant to ensure the material was successfully removed. Furthermore, based on the sporadic nature of debris identified on the ground, Broadbent recommends, in accordance with industry standards, that the Mill Site Area is further evaluated at the time of the abatement activities by a Nevada licensed asbestos building inspector. In the event additional ACM or suspect ACM is identified, this material should be removed by the licensed abatement contractor in accordance with OSHA work practices applicable to the type of material encountered. Suspect materials should be assumed to be hazardous and handled as such unless laboratory analysis has been performed.

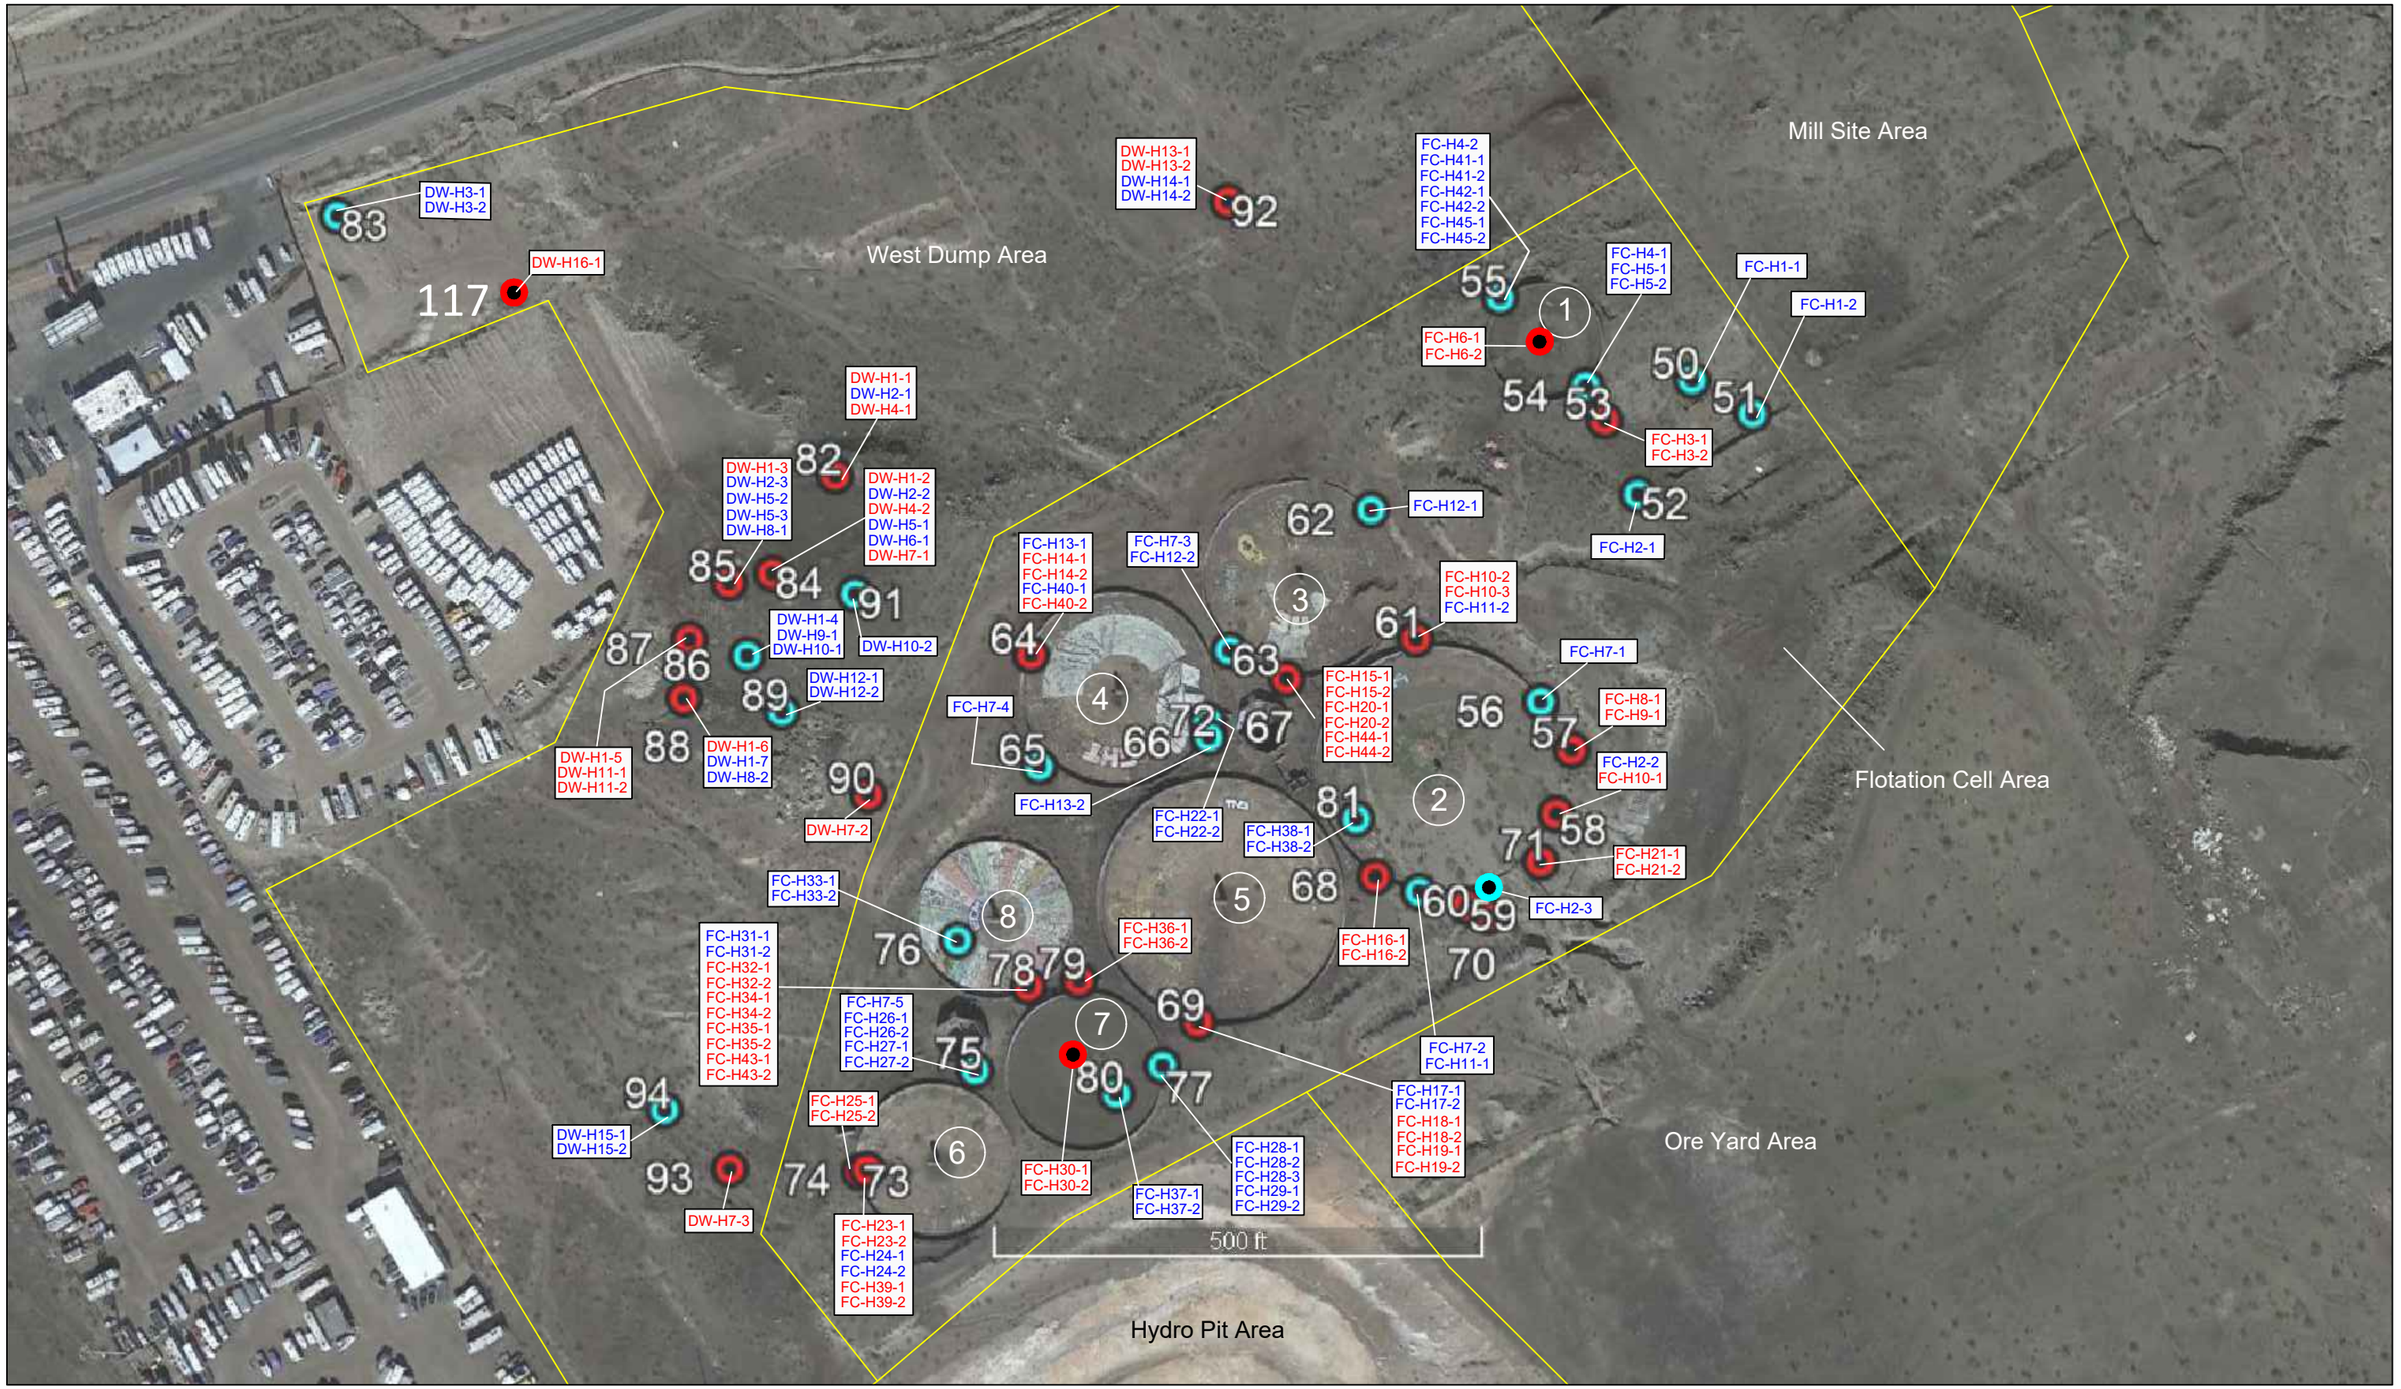
Mill Site Area Sample Locations
